CHCNAV NX510 FAQ

Precision Agriculture | October 2023

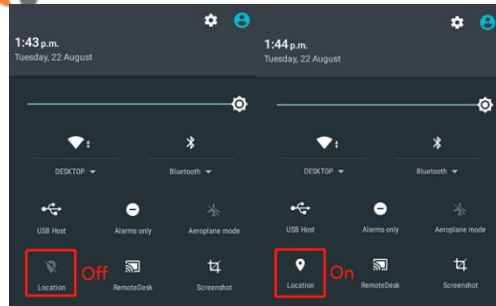
1. Restart the whole system.
2. Swipe the screen down from the top of the tablet to open the control panel and check if **[Location Information]** is grey and off. If it is on, turn it off and restart the whole system.

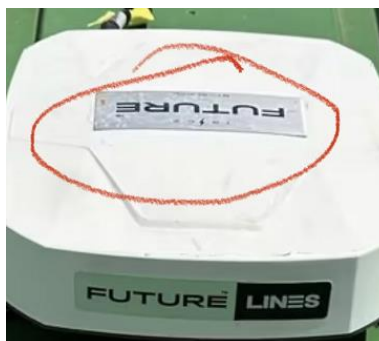
Check whether there is interference around (positioning terminal or high-power electrical appliance), and if any, power off or remove the interference part.

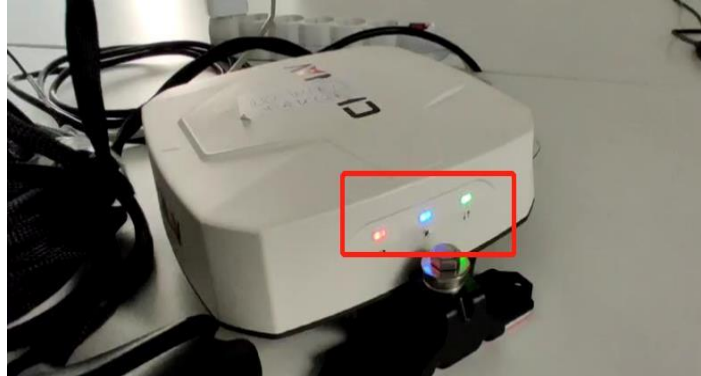
5.1 Three lights are on

Restart the system first. If still not working, please contact CHCNAV technicians to debug remotely with special cable. If no this special cable, it is necessary to replace the receiver or replace the mainboard.

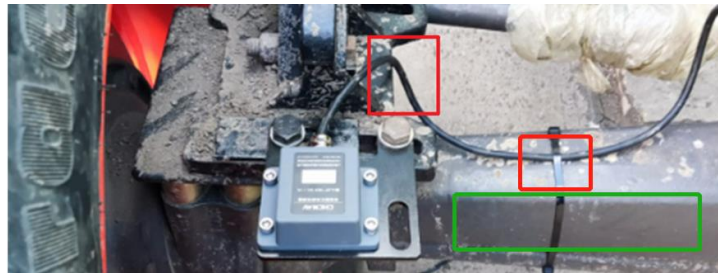
Notification:

- b) Fix the cable on the side of the axle with ribbon instead of the top side;
- c) Improve the wire quality;
- d) Reserve a sufficiently long wire.

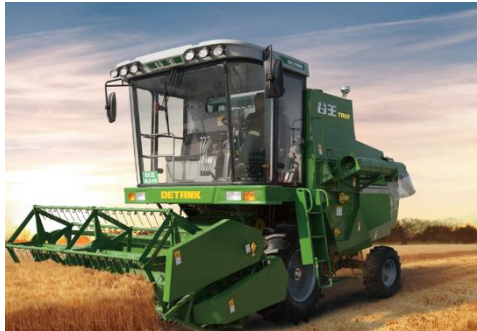
PGain: 30/35

DGain: 60/80

Steering Deadzone: 15

Online Aggressiveness: 60/70

Combined harvester---Rear wheel steer
